Inspection Report

Property Address:
100 SE 1st Ct
Cape Nowhere FL 33333

This 4 point inspection is at the insurance companies request and is not the entire report. There was no exact criteria list to determine what information the insurance company wanted from the original inspection except for Plumbing, Electrical, Heat/Air conditioning and Roofing. Other deficiencies may exist in this home which could effect value or safety and may not be included in this minimal inspection. It is recommended that the interested party review the entire report.

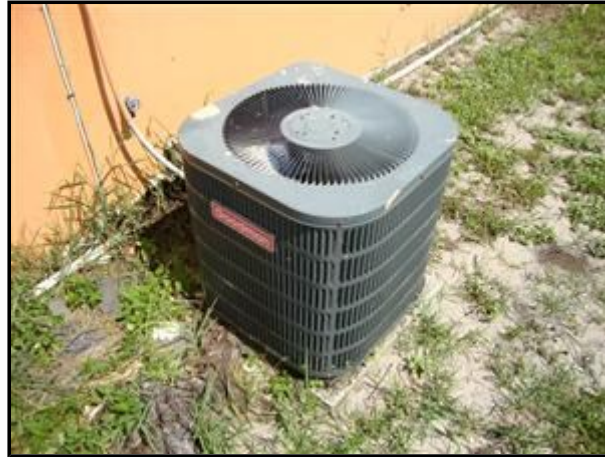
A. Picture 1

The cooling systems are in good working condition.

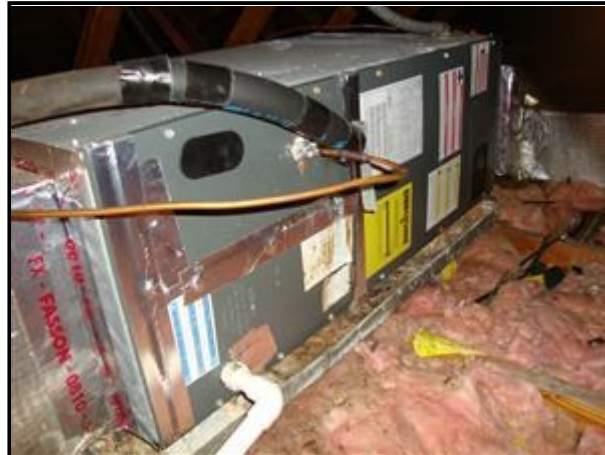
B. Picture 1

The heating systems are in good working condition.

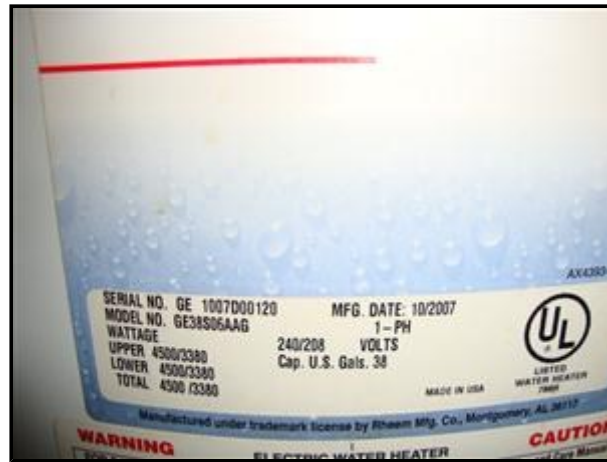
Plumbing is in good working condition.

A. Picture 1 Water Heater

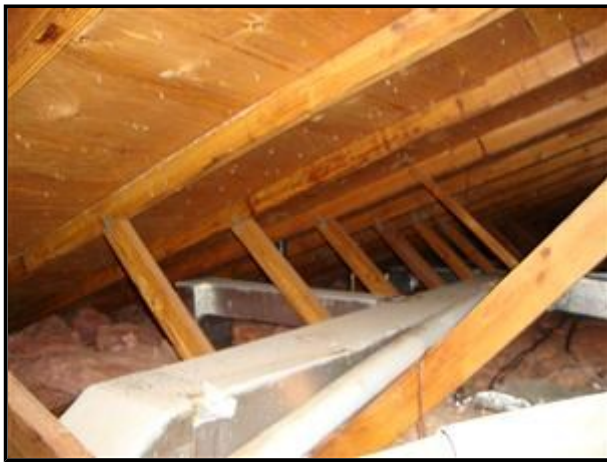
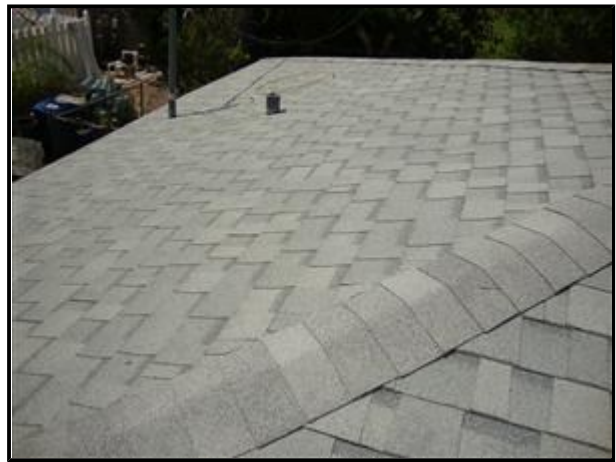
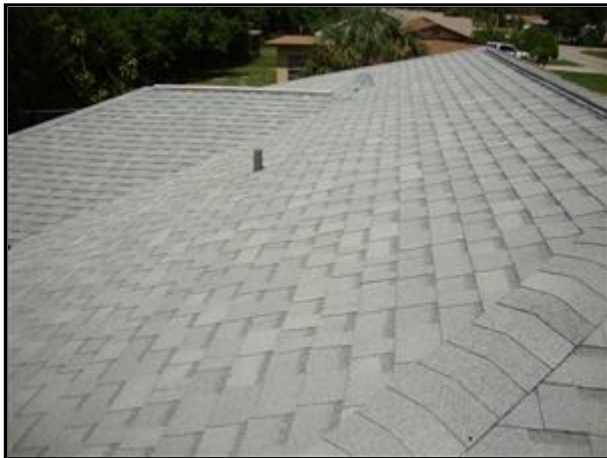
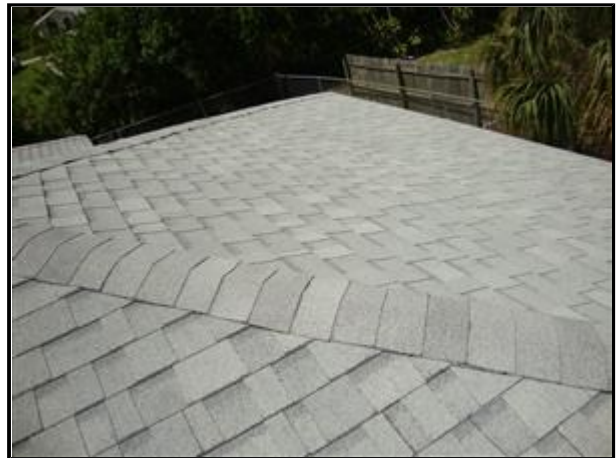
Roof system is water tight at this time.

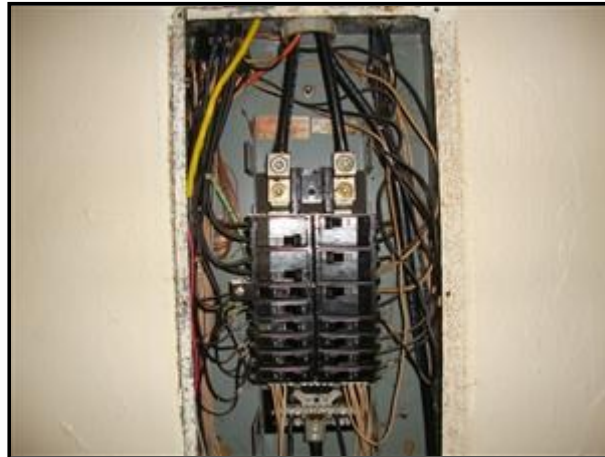
A. Picture 1

Electrical system is in good working condition at this time.
