Inspection Report

Property Address:
100 SE 1st Ct
Cape Nowhere FL 33333

[1 Three Part Drywall Abatement - Initial Inspection](#)

Date: 7/23/2010	Time:	Report ID:
Property: 100 SE 1st Ct Cape Nowhere FL 33333	Customer: John Smith	Real Estate Professional:

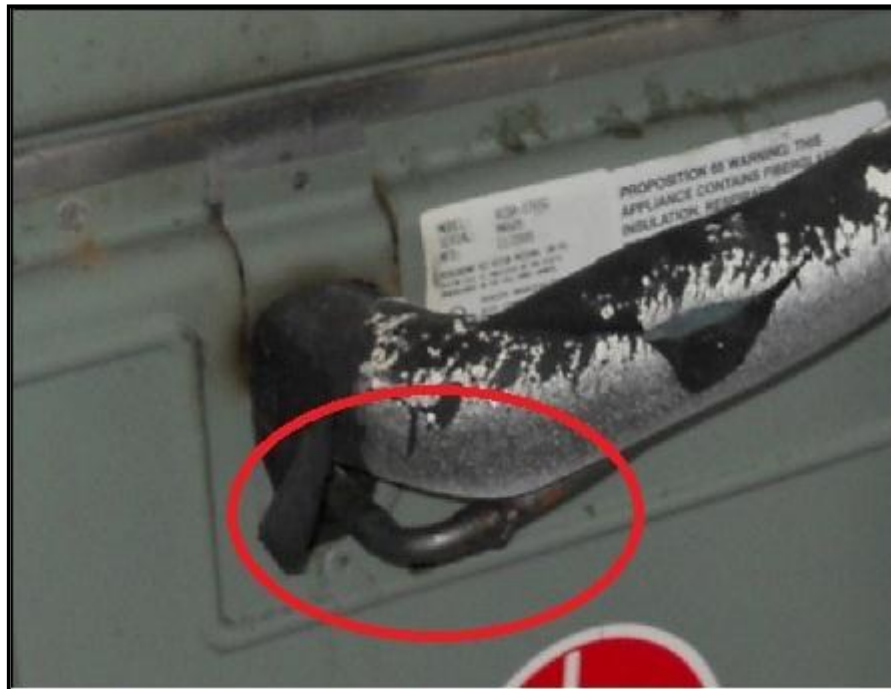
1.2 Picture 1

1.2 COOLING COILS IN AIR HANDLER ARE BLACKENED

Comments: YES

View of copper at air handler.

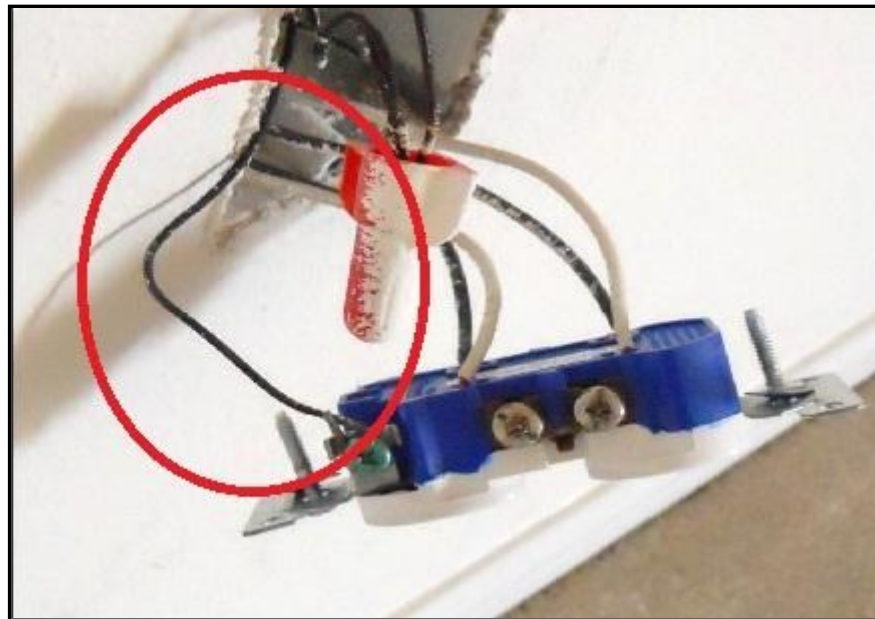
1.4 Picture 1

1.4 BLACKENING OF COPPER ELECTRICAL WIRING

Comments: YES

View of copper electrical wiring.

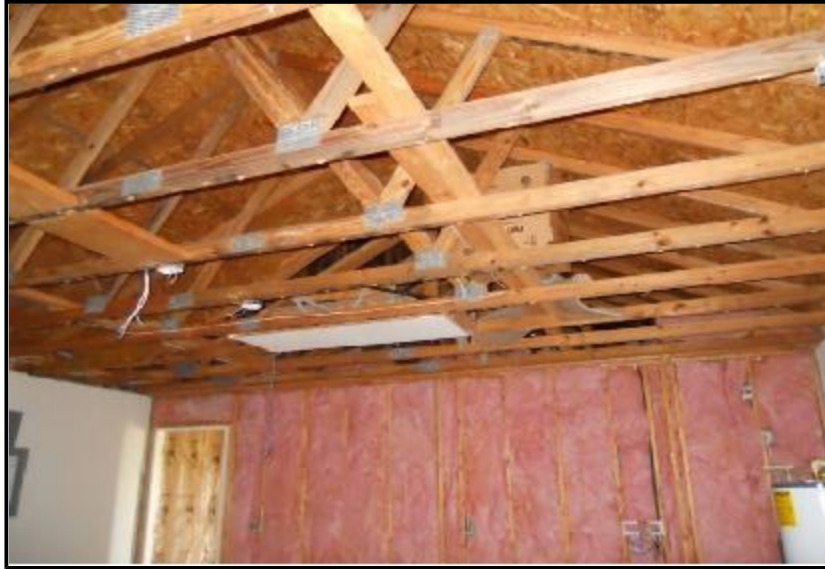
2.0 Picture 1

2.0 ALL DRYWALL IN HOME HAS BEEN REMOVED

Comments: YES

(1) View of garage.

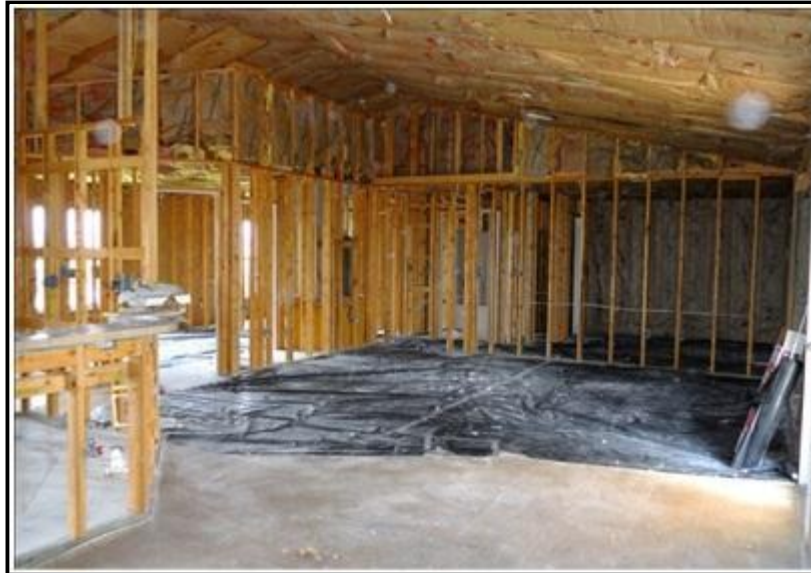
2.0 Picture 2

(2) View of interior.

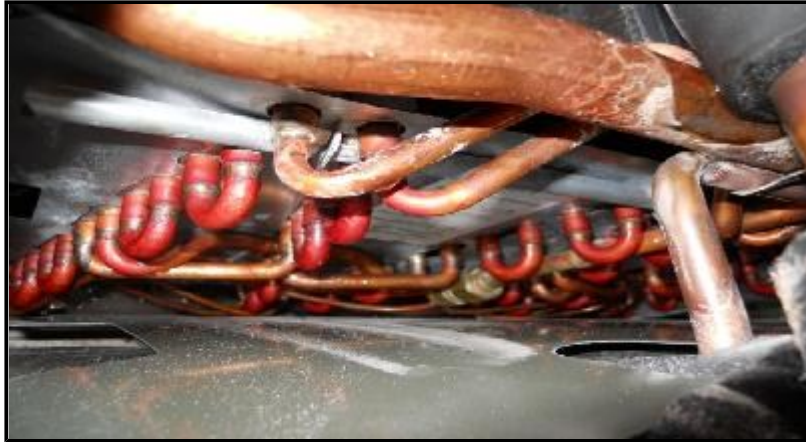
2.4 Picture 1

2.4 AIR HANDLER COILS HAVE BEEN REPLACED

Comments: YES

View of copper coils in air handler.

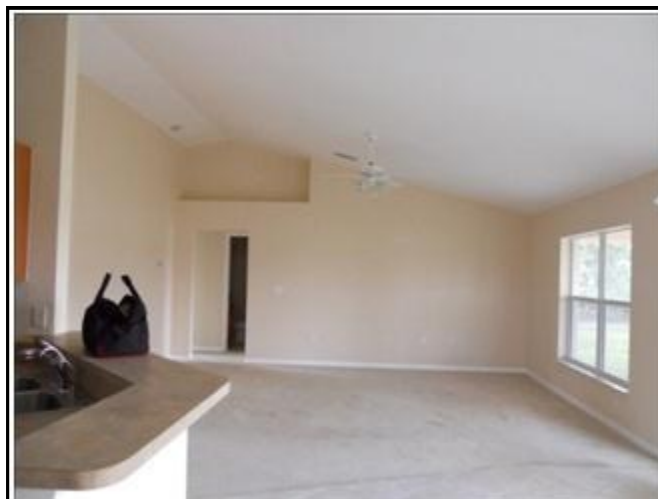
3.0 Picture 1

3.0 NEW DRYWALL HAS BEEN REINSTALLED THROUGHOUT HOUSE

Comments: YES

View of Interior.

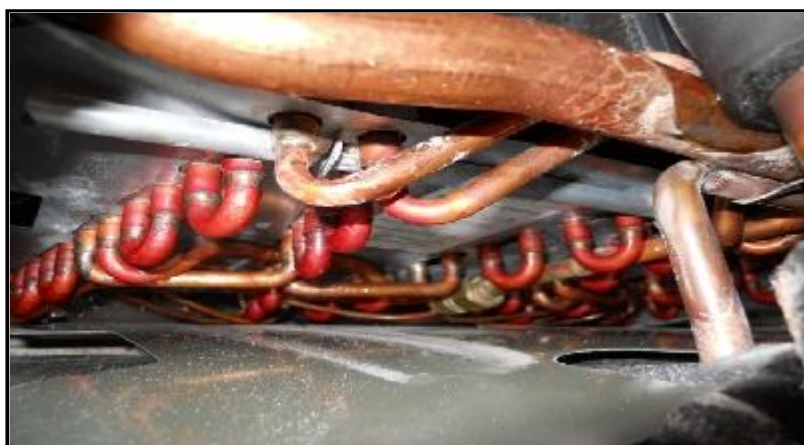
3.3 Picture 1

3.3 COOLING COILS IN AIR HANDLER ARE BLACKENED

Comments: NO

View of copper coils in air handler.
